4140 12th Ave. So. Minneapolis, MN 55407

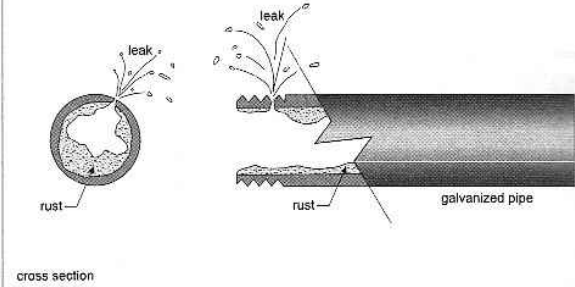
**Galvanized steel pipe**

rusting of galvanized pipe can greatly reduce water pressure and will eventually cause leaks as rust creates holes in the pipe walls

problems are likely to occur soonest on pipes carrying hot water, horizontal pipes and at threaded (thinner) sections

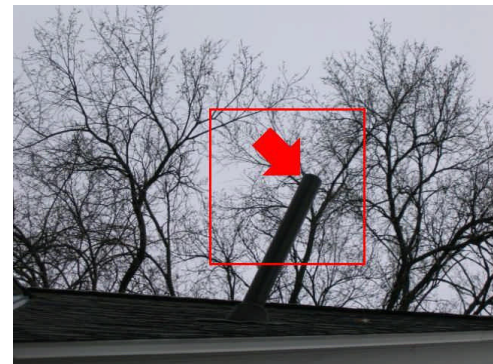
Appears serviceable, Vents terminated improperly. More than 12" protrusion, could freeze and block gases, repairs needed.

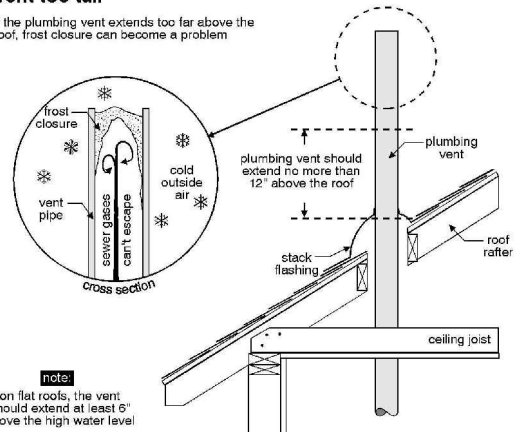
**Vent too tall**

if the plumbing vent extends too far above the roof, frost closure can become a problem
